TECHNICAL MEMORANDUM

DATE 17th March 2023 21467213.CO4.11.B.0

DTSF QUALITATIVE FLOOD RISK ASSESSMENT

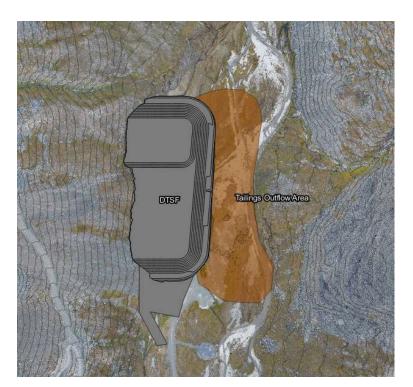
Figure 2: Projected tailings outflow area - Sunny day scenario

selected failure scenario and the estimated tailings released volume, the majority of the released volume will deposit within the river floodplain, obstructing the river main channel. Projecting the volume of material expected to be lost from the DTSF in light of a failure (i.e. 100,000 m³) into the river channel (using LiDAR) it is expected that the sludge plume will extend a distance of approximately 80m from the breached wall, causing an almost full blockage of the Kirkespir River valley.

- Assuming a "less worst case" and more likely scenario, tailings will partially obstruct the river channel and floodplain: this could lead to a limited amount of water accumulating upstream of the obstruction. The scenario could result with the river eroding the eastern portion of the tailings outflow, where the tailings have a reduced thickness, and transporting the material downstream.
- Assuming a "worst case" scenario and less likely, tailings will completely obstruct the river channel and floodplain: this could lead to a large volume of water accumulating upstream of the tailings obstruction, which would act like a dam. Water could keep accumulating upstream of this "dam" until the erosive processes create a breach into the obstruction, or the "dam" is overtopped.

The typical flow velocity is in the order of 2 m/s in the Mean Annual Discharge (MAD) event. Any blockage in the river will reduce the available flow area and increase the energy (and hence velocity) of the flow, progressively mobilising the material and washing it downstream. Under typical "sunny day" flow conditions however, flow conditions are relatively shallow and low energy. It is therefore expected that the tailings will settle out along the length of the river valley within a relatively short distance of the failed DTSF. Fines will also discolour the river flow and this will create a visible plume into the fjord.

Consequently, whilst there will be a significant visual impact, the net environmental harm is expected to be short-term and reversible.
