Nalunaq Gold Mine, Greenland

Preliminary Geotechnical Report - Mine Surface Infrastructure

Golder Associates (UK) Ltd

February 2021

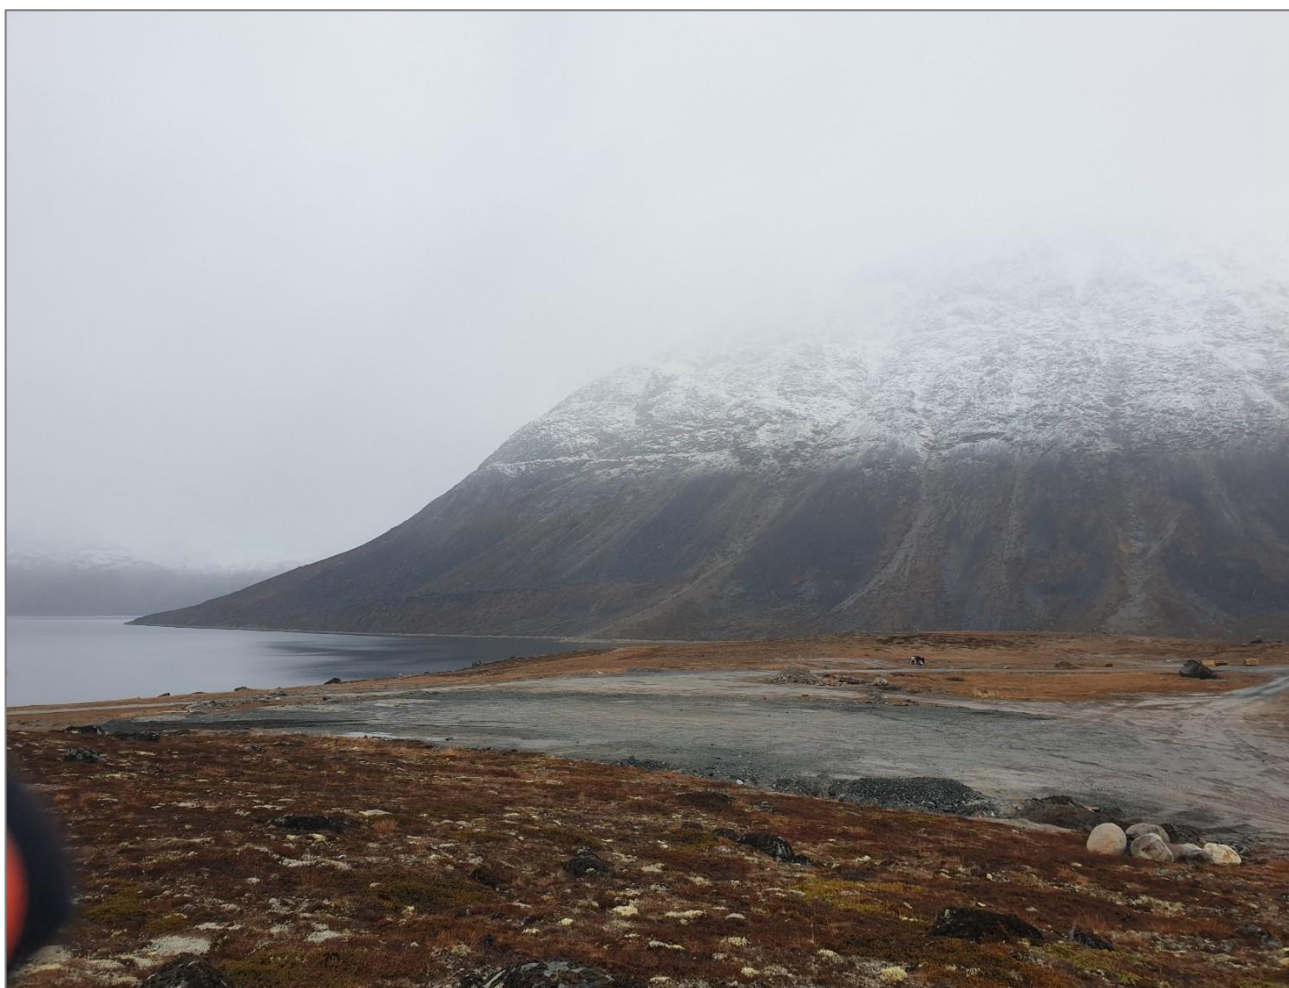
Figure 3: View from the temporary (2020) site office north across the proposed camp area on a raised beach above the Sarqå Fjord

In the proposed camp and beach landing area (Figure 3) the deposits form a raised beach, the composition of which is dominated by sand with some gravels. No clay deposits of significance were identified within the surficial deposits.

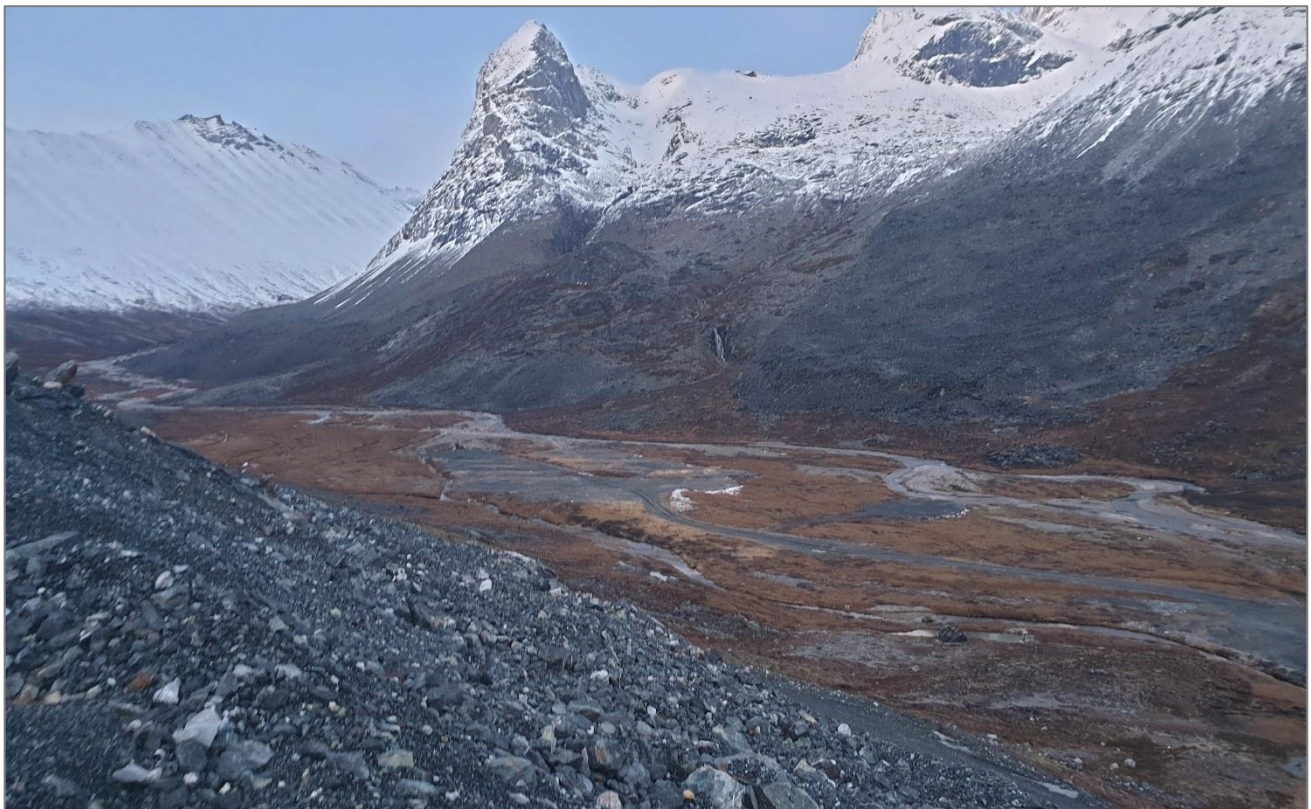
Figure 5: View of the proposed DTSF and process plant areas from the 300 m Level portal, showing the braided channel of the Kirkspir River

The valley may be broadly divided into two areas: a lower section below the Repeater Station (Figure 2) where the river descends approximately 70 metres (m) over a distance of approximately 500 m via a series of small rapids; and an upper section east of the Repeater Station where the area for the proposed DTSF and process plant is situated in the braided channel of the Kirkespir River (Figure 4 and Figure 5).

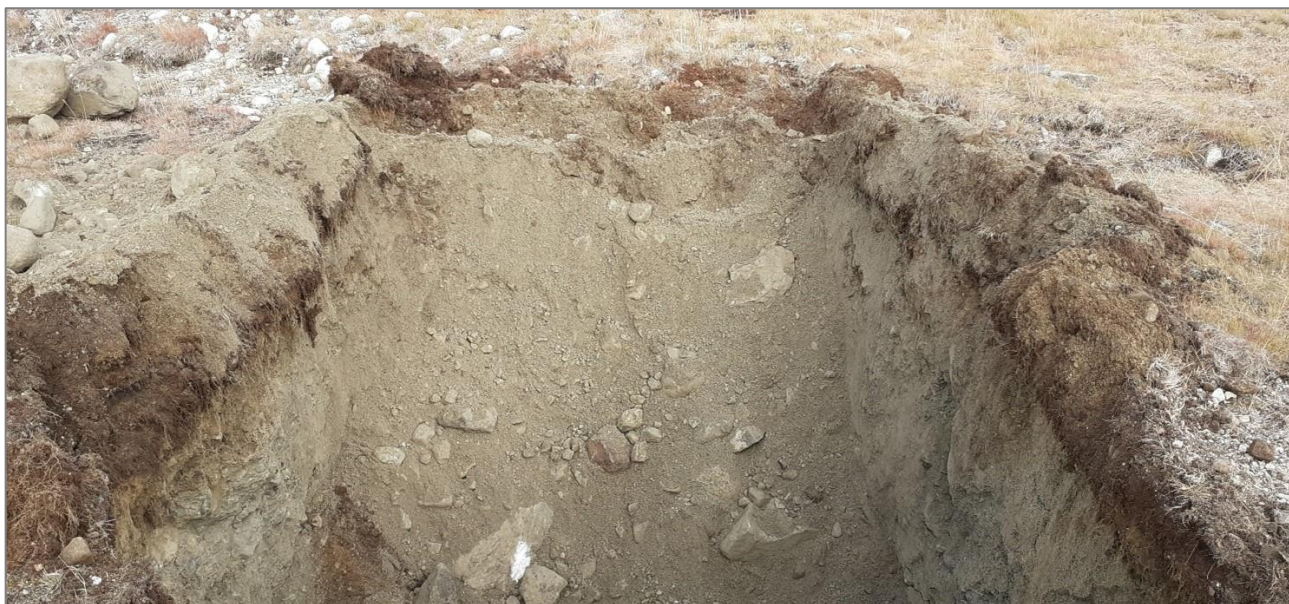
Figure 17: Trial Pit TP-07 at the proposed camp

Logs of the trial pits excavated (TP07 and TP08) are presented in APPENDIX C and their locations are shown on Figure 16. Photographs of each trial pit are presented as Figure 17 and Figure 18.

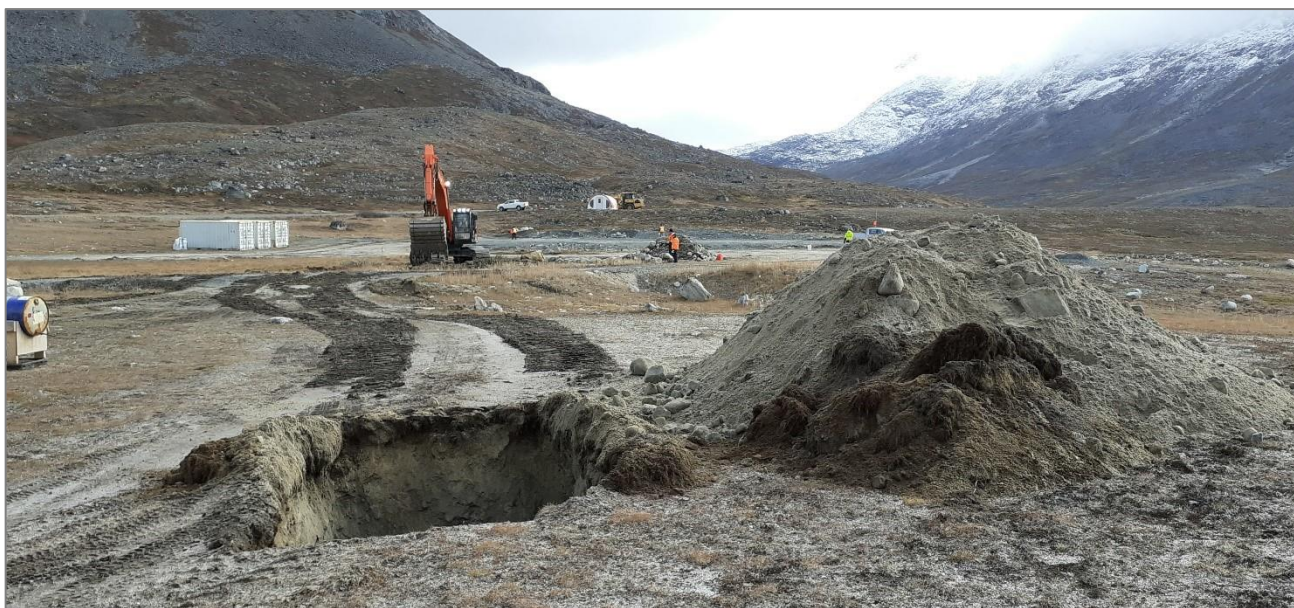
Figure 18: Trial Pit TP-08 at the proposed camp

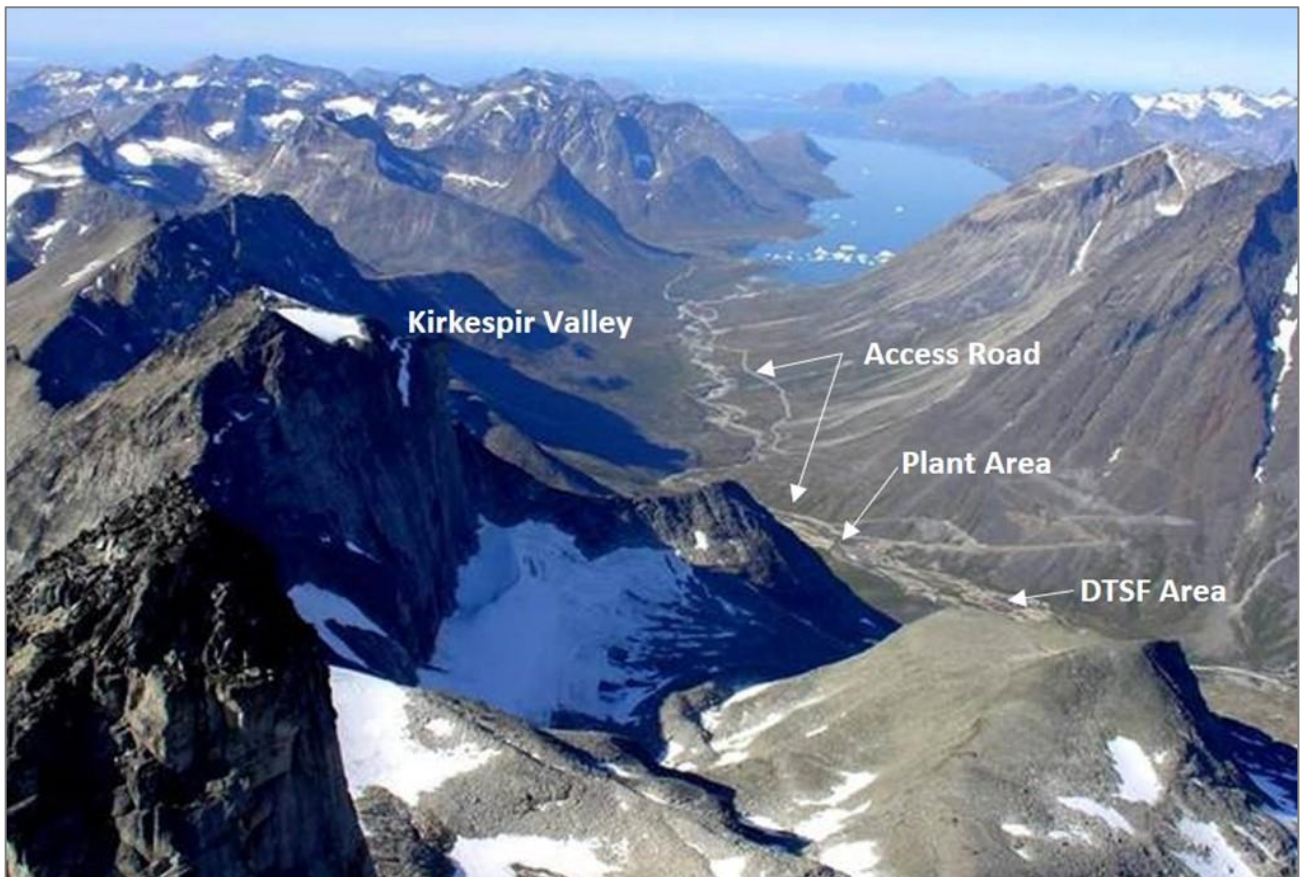
Figure 20: Nalunaq Mine access road (Photo Source: AEX Gold)

Based on field observations in October 2020 the ground conditions along the access road route are dominated by alluvium within the Kirkespirdalen floor and talus and debris flow deposits on the slopes. No intrusive (drilling or trial pitting) investigations have been undertaken specifically along the road. Two boreholes drilled as part of the investigation of Borrow Pit 2 (BH01-08 and BH01-09) were drilled in the vicinity of the road during the 2001 site investigation. BH01-08 was drilled to a depth of 9.2 mbgl encountering talus to its full length, described as boulders, cobbles, gravel, sand and trace silt. BH01-09 was drilled to a depth of 6.6 mbgl (refusal) also encountering talus, described as very dense, moist and brown becoming grey at 3 mbgl with boulders, cobbles, gravel, sand and trace silt.

The existing gravel road appears to be in fair condition for most of its length although it is considered that maintenance will be required to minimise damage due to freeze-thaw cycles and heavy rain. The use of well-graded material for the rehabilitation of sections of the road that are in poor condition, the improvement of the drainage system and adequate crossfall in those areas will need to be considered in the design.

Avalanche, rockfall (Golder, 2020a) and debris flow hazards should be considered in the design as well as drainage to avoid erosion of the road surface.

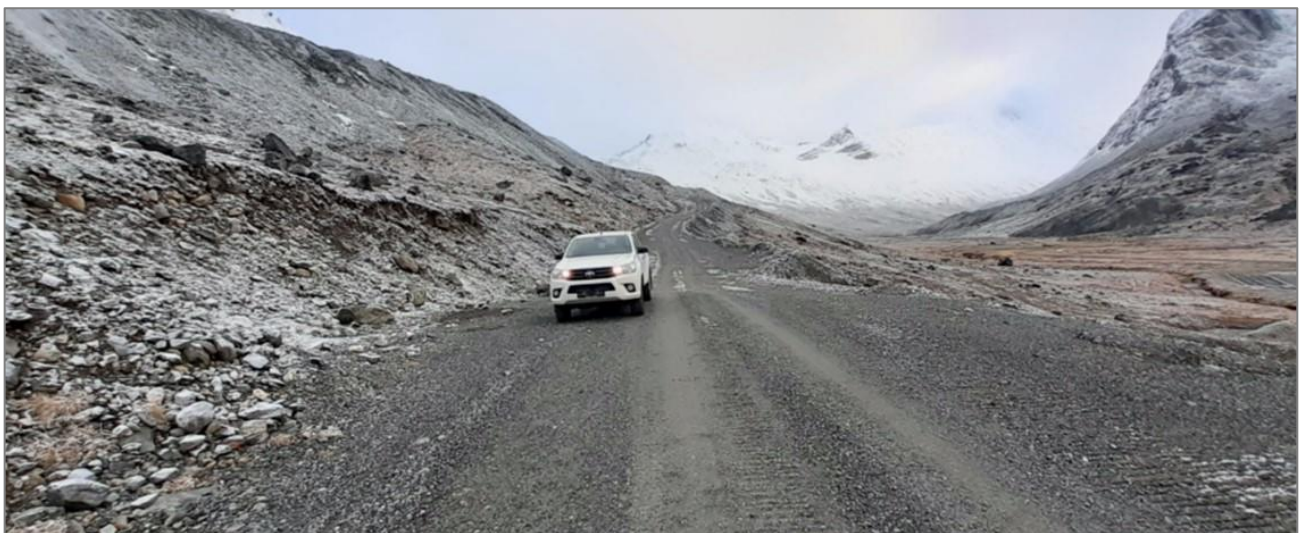
Figure 21: Mine access road near the proposed process plant

The existing gravel road constructed during previous mining operation connecting the pier to the proposed process plant an DTSF area is currently (October 2020) used to access the Nalunaq Mine site for exploration activities. An aerial view of the access road is presented in Figure 20 with a typical section shown in Figure 21.

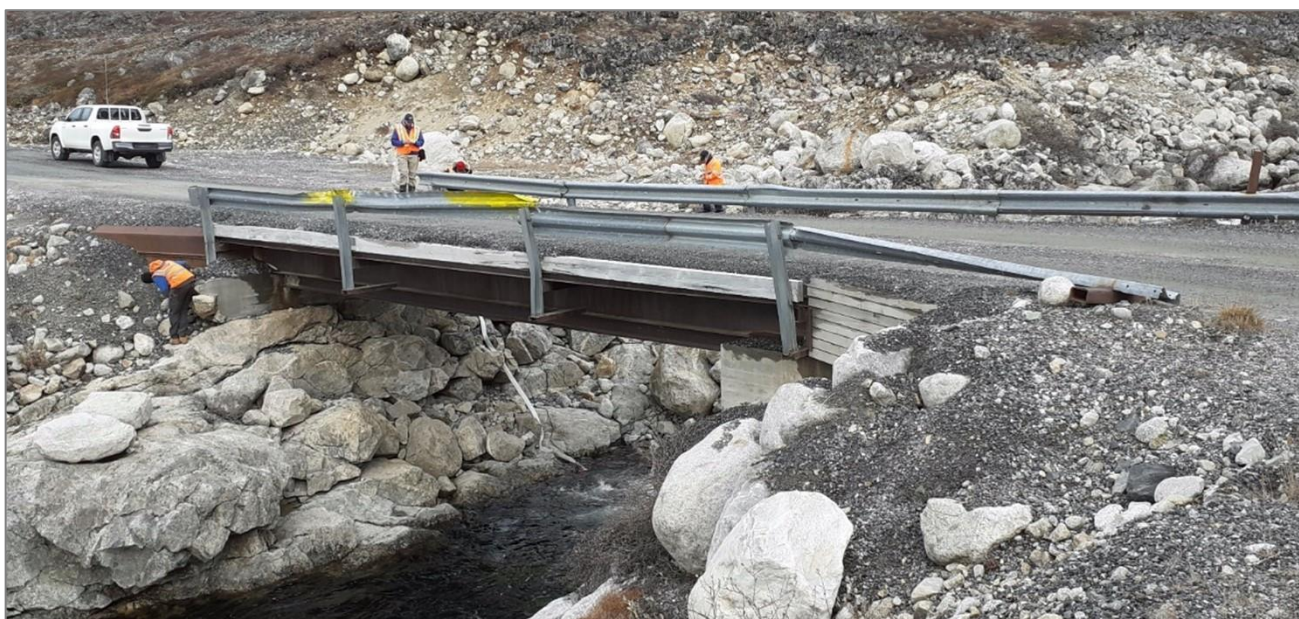
Figure 23: Access Road river crossing between the pier and the proposed camp

Two river crossings (bridges) exist along the access road from the pier area to the proposed process plant site (Figure 22). The bridge over the Arpatsivip stream crossing between the pier area and the proposed camp site is shown on Figure 23 and the container bridge over the Kirkespir River is shown on Figure 24.

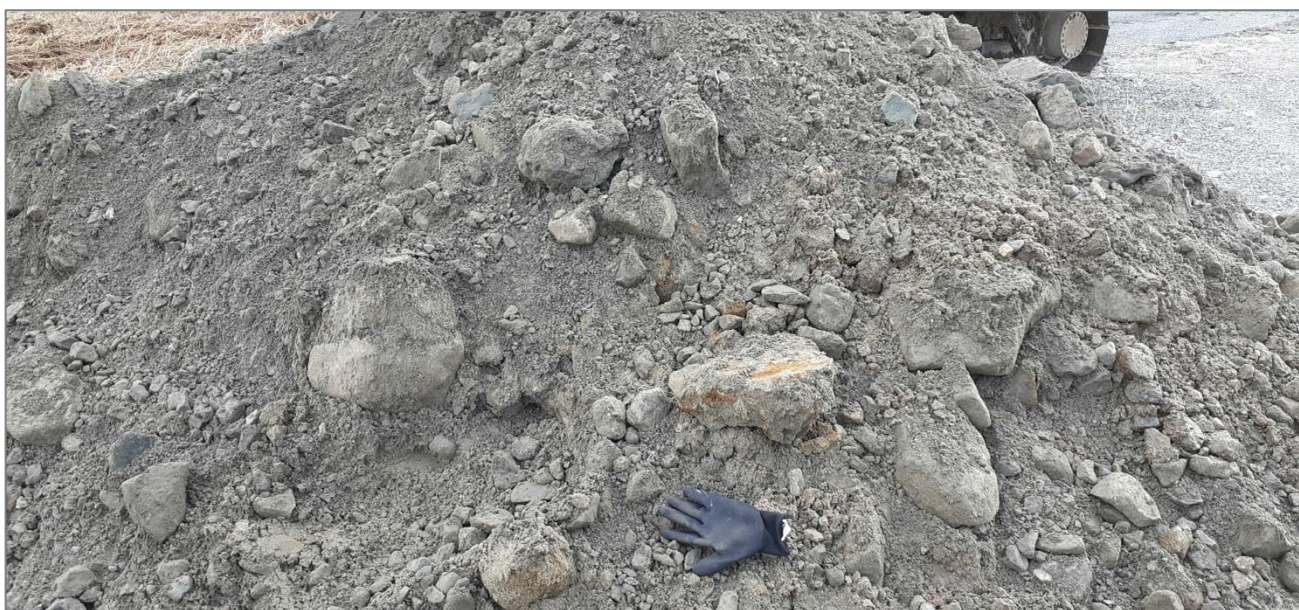
Figure 26: Excavated materials from TP-05 in the proposed DTSF area

Two trial pits were excavated in the proposed area for the DTSF denominated as TP-05 and TP-06 (Figure 26 and Figure 27). The pits were excavated to a total depth of 1.8 m and 3.0 m respectively. Logs for the trial pits are presented at APPENDIX C.

The material encountered in TP-05 comprised 0.2 m of well graded sand with gravel (GW as per ASTM 2488) considered as fill placed during previous Mine operation and well graded sand with gravel, cobbles and boulders (SW as per ASTM 2488) (Figure 26) to a maximum excavated depth of 1.8 mbgl. Groundwater was intercepted at 1.8 mbgl. A sample of alluvium from a depth of 1.7 mbgl was selected for testing (test schedule and results are presented at APPENDIX C).

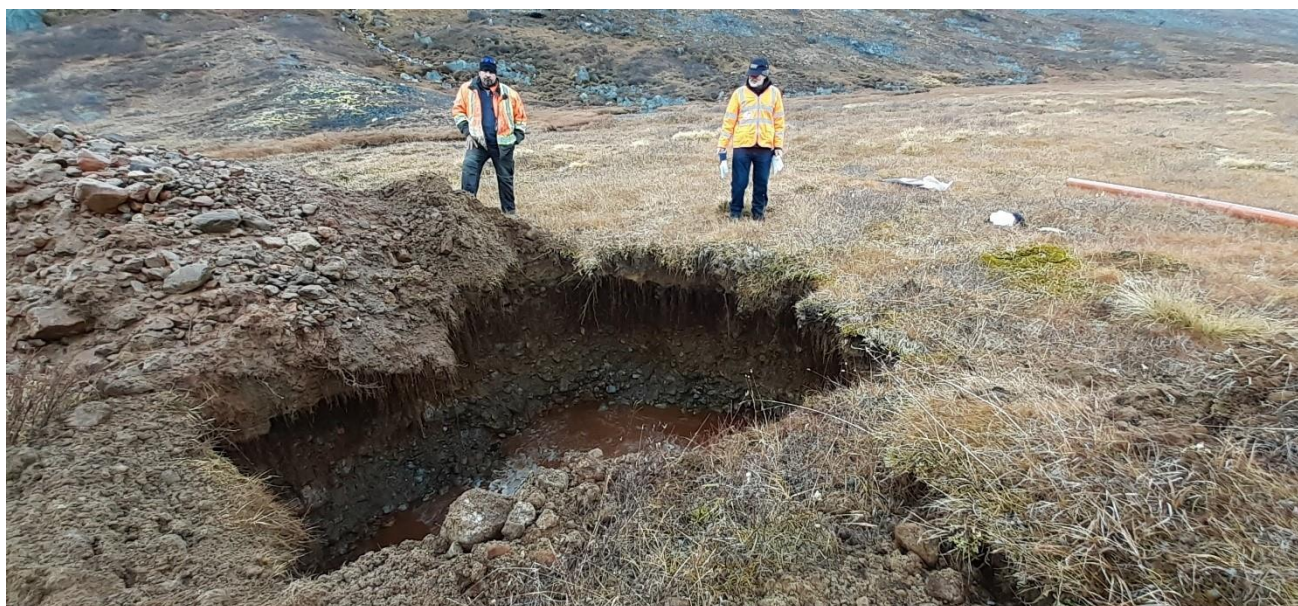
Figure 27: Excavated material from TP-06 in the proposed DTSF area

The material encountered in TP-06 (Figure 27) comprised 0.15 m of loose brown gravel with sand, cobbles and organic matter (TOPSOIL) underlain by brown boulders, cobbles and gravel with sand (ALLUVIUM) to a maximum excavated depth of 3.0 m. Groundwater was intercepted at 1 mbgl.

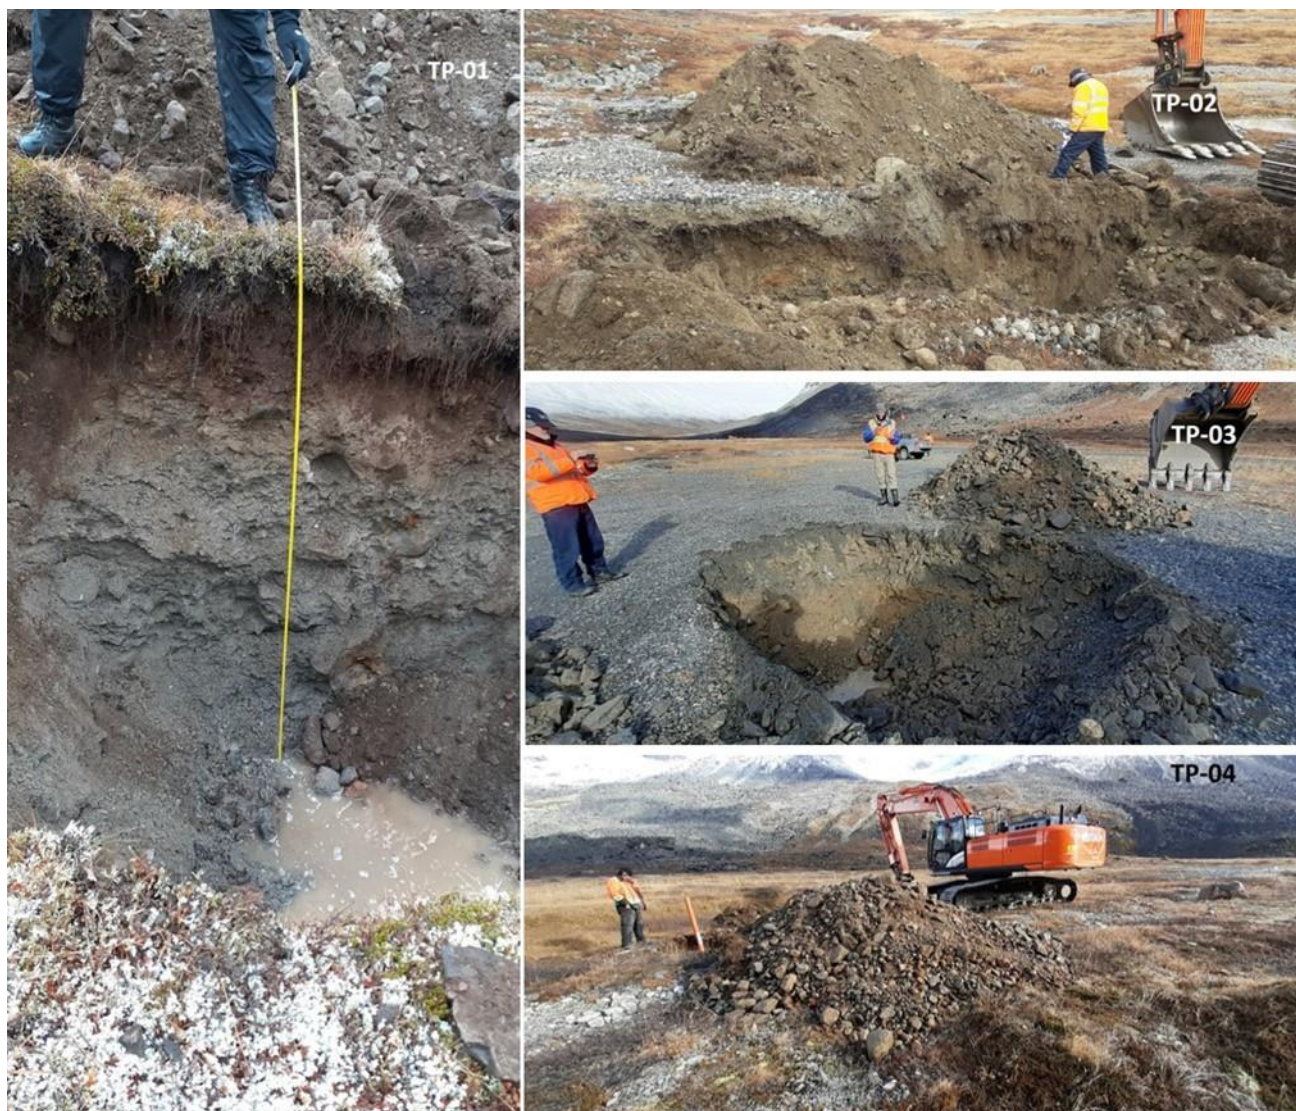
Figure 28: Trial Pits TP-01, TP-02, TP-03 and TP-04 excavated in the proposed process plant area

In TP01, TP02 and TP04 TOPSOIL comprising loose brown coarse gravel with sand, cobbles and organic matter was encountered to a maximum depth of 0.15 mbgl. MADE GROUND comprising dry, loose grey gravel and cobbles was present to a depth of 0.3 mbgl in TP03.

Photographs of the trial pits and the soils excavated are presented in Figure 28. Samples of alluvium from TP01 and TP04 were selected for laboratory testing (a test schedule and results are presented at APPENDIX C).

The critical elements to be addressed during the design of foundations for the process plant structures and the assessment of stability for the DTSF are shallow groundwater levels, flood risk and potential for freeze-thaw cycles in winter. It is recommended that this is given careful consideration in the next stage of the project.

As the proposed process plant area is within the braided channel of the Kirkespir River foundation preparation works should include construction of a fill pad. Erosion protection will need to be provided in the design of the

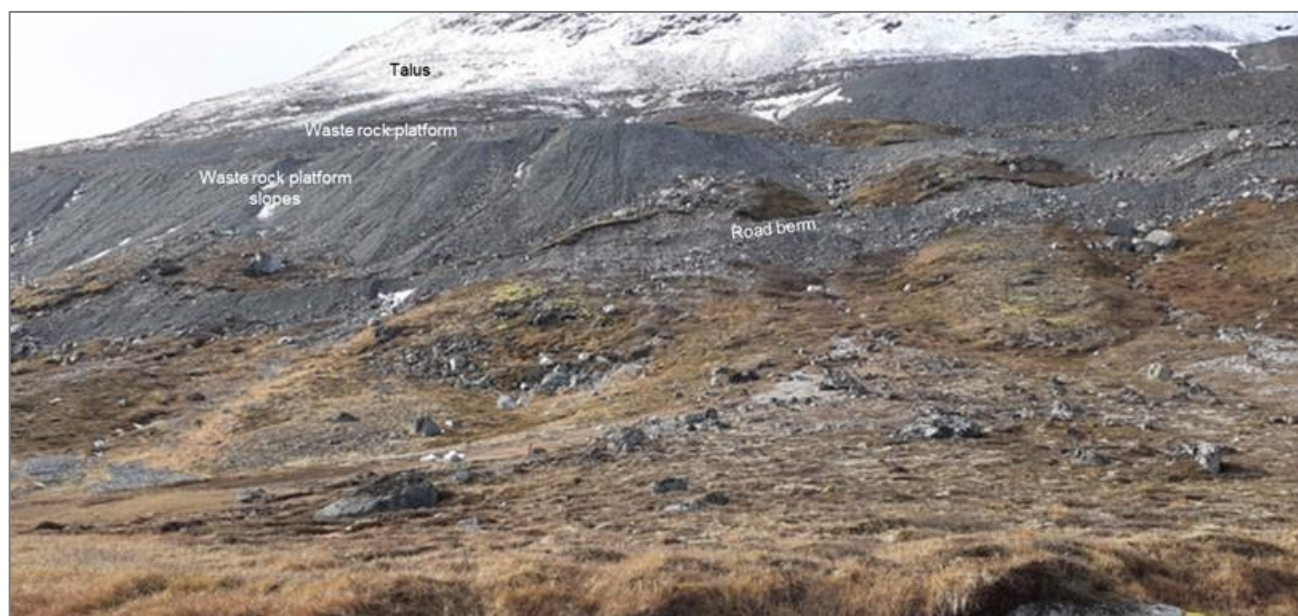
Figure 29: Existing waste rock platform at the 300 Level portal dumps showing slopes (view from the proposed process plant area)

The existing 300 Level Mine portal platform was constructed during previous operation of the mine using waste rock (Figure 29). It is understood that the original ground slope beneath the waste rock platform varied between 19° and 26° and comprised overburden of sand, gravel, cobbles and boulders of various thicknesses (Golder, 2003), interpreted to be talus deposits.

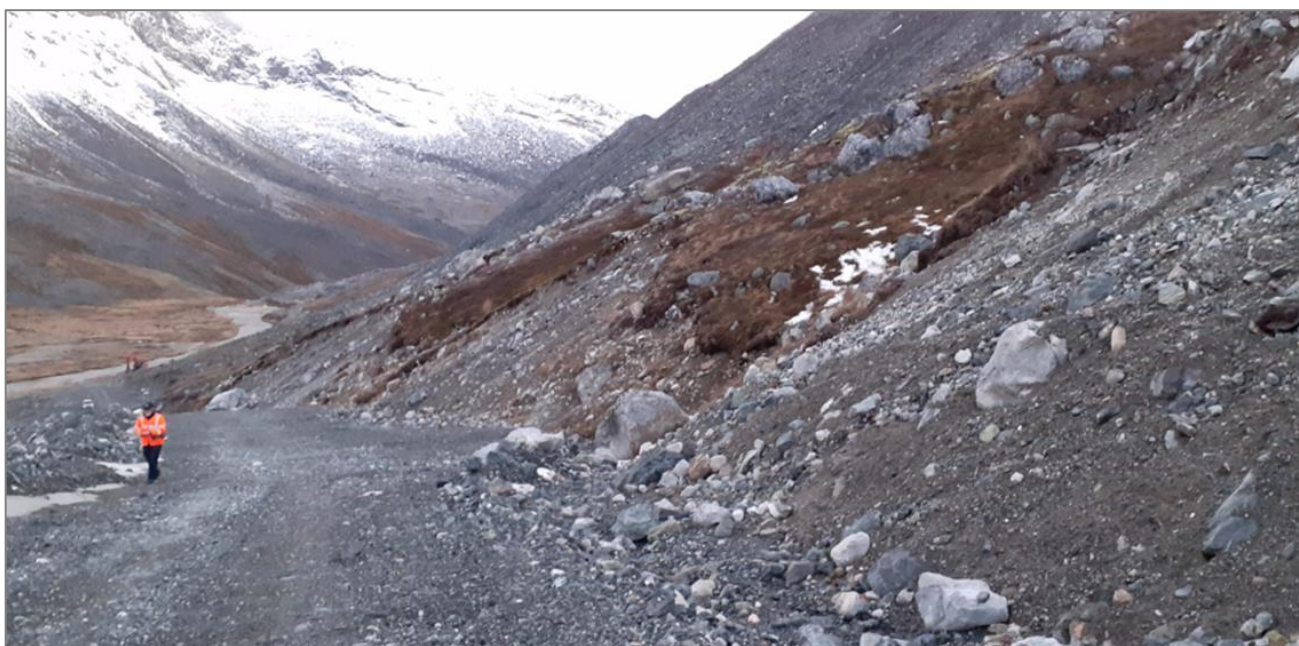
Figure 32: View south of the existing haul road from the proposed process plant area to the 300 Level platform.

It is considered that the haul road connecting the proposed process plant area with the 300 Level portal platform has an excessive gradient for the safe transportation of ore (up to 19% in some sections). It is understood from AEX personnel that a one-way system will be adopted for the existing road (Figure 32). As per the access road, the depth of surficial soils will need to be confirmed if an assessment of the potential for realignment of the road (to decrease the slope in steep sections) is undertaken to inform the design of the road including the requirement for cut and fill.

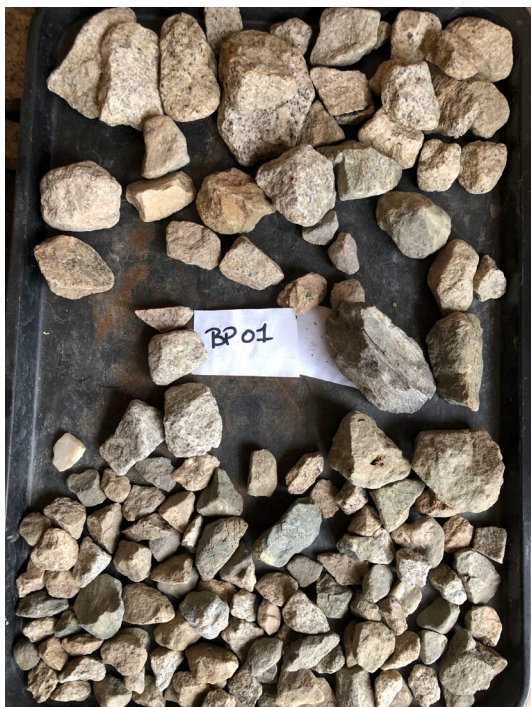
Granite
fragments

Gneissic
fragments
