TECHNICAL MEMORANDUM

Reference No. 21467213.C04.1.B.0

TAILINGS STORAGE FACILITY OPTIONS ANALYSIS

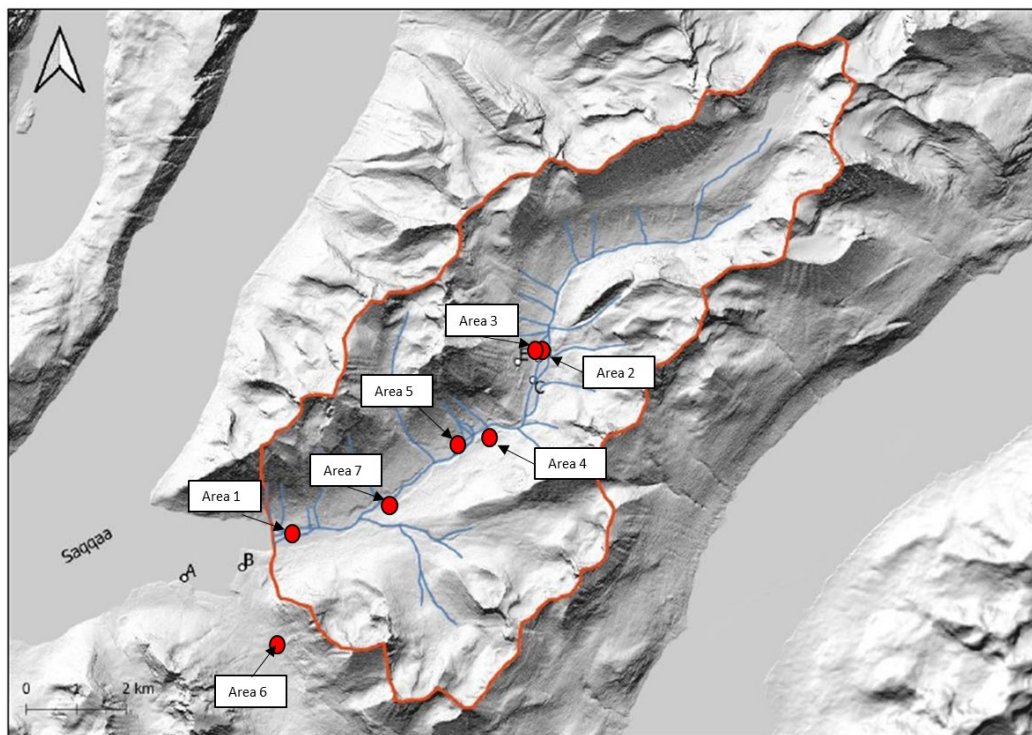
Figure 1: Approximate locations of potential DTSF sites

Seven potential areas (numbered 1 to 7) have been identified and are shown on in Figure 1. Descriptions of Areas 1 to 7 are outlined below. Site 1 (Figure 1) was found to have a fatal flaw due to its presence on an archaeological site (Golder Associates, 2002) and has not been considered further.

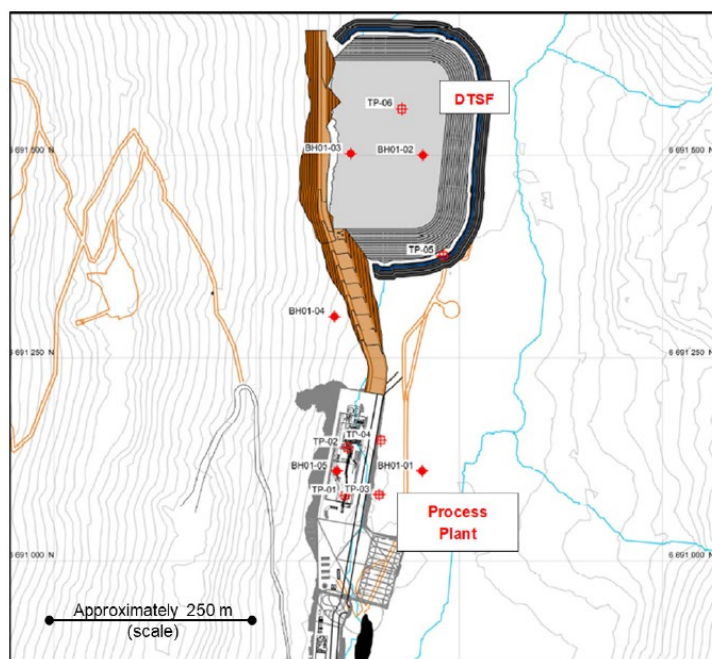
Figure 2: Area 3 Proposed DTSF and Process Plant Layout and investigation locations

Area 3 (Figure 2) is situated in the upper part of the Kirkespirdalen, to the north-east of the Repeater Station. The site is accessed via existing gravel roads and lies against the talus slope on the west side of the valley.

Subsurface conditions were investigated by the installation of 5 boreholes and 6 trial pits. The valley floor is underlain by alluvial deposits comprising cobbles and boulders with sand and gravel (alluvium) overlying glacial till and bedrock (Golder, 2021).
